Manhole Inspection Summary

Manhole # S41A__010MH

Inspection ☐ Is Incomplete Rating: **3) Fair**

Location Address: **500 n caroline st** Cross Street: **2nd parking lot**

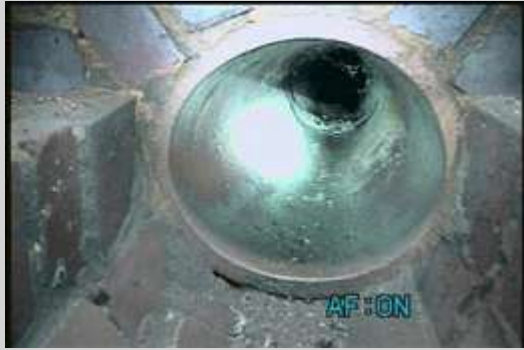
6 O'Clock Inflow

8 in. Circular Gravity Sewer

Pipe In @ 6 O'Clock

Pipe Material: **Clay** ☐ Pipe Lined

Infiltration: **None** Pipe Seal Cond: **Unknown**

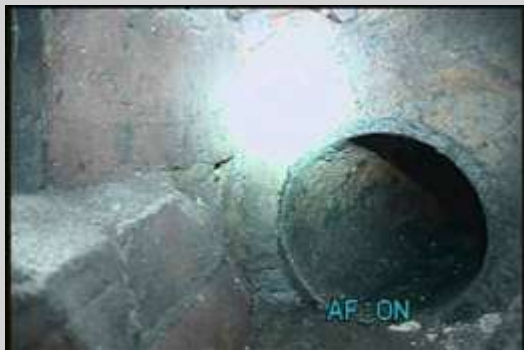
9 O'Clock Inflow

8 in. Circular Gravity Sewer

Pipe In @ 9 O'Clock

Pipe Material: **Clay** ☐ Pipe Lined

Infiltration: **None** Pipe Seal Cond: **Unknown**
